NASA Contractor Report 159231

# Flight Service Evaluation of Kevlar-49 Epoxy Composite Panels in Wide-bodied Commercial Transport Aircraft

# Sixth Annual Flight Service Report

LOCKHEED-CALIFORNIA COMPANY  
BURBANK, CALIFORNIA

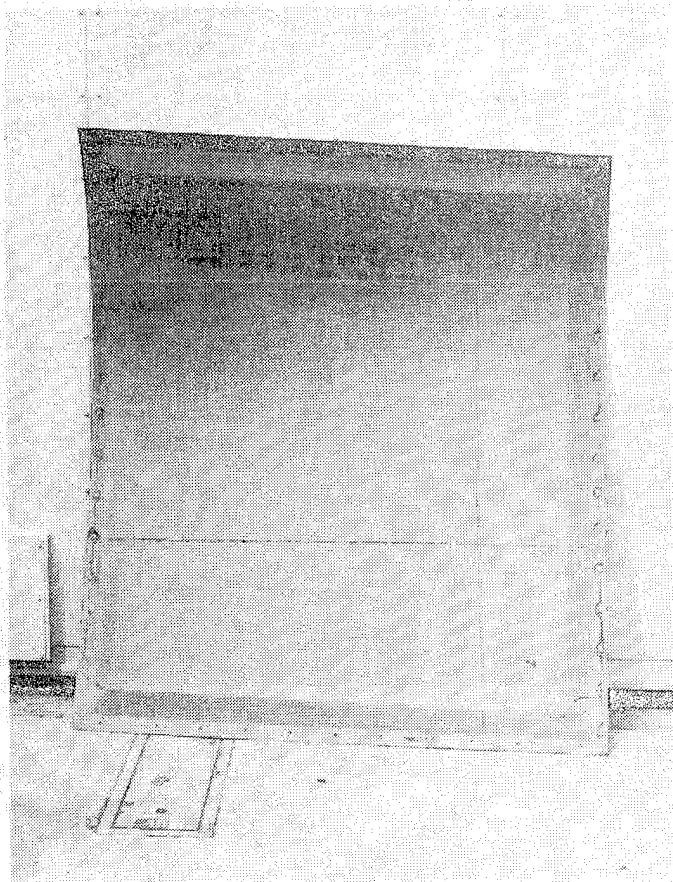
Figure 1. - Right-hand wing-body fairing-inner surface.

- o A left-hand and right-hand set of a large 152- by 170-cm (60- by 67-inch) sandwich wing-body fairing panel. The exterior skin is 0.05 cm (0.02 in.) thick with one ply of 181 style Kevlar-49 fabric and two plies of 120 style Kevlar-49 fabric. The interior skin is 0.04 cm (0.015 in.) thick with three plies of 120 style Kevlar-49 fabric. The honeycomb core is Nomex with 0.3 cm (1/8 in.) cells, and 0.05 gm/cm<sup>3</sup> (3.0 lb/cm ft) density. Overall panel thickness is 2.24 cm (0.88 in.), with a solid laminate edge 0.25 cm (0.10 in.) thick, built up of 181 style Kevlar-49 plies (figure 1).

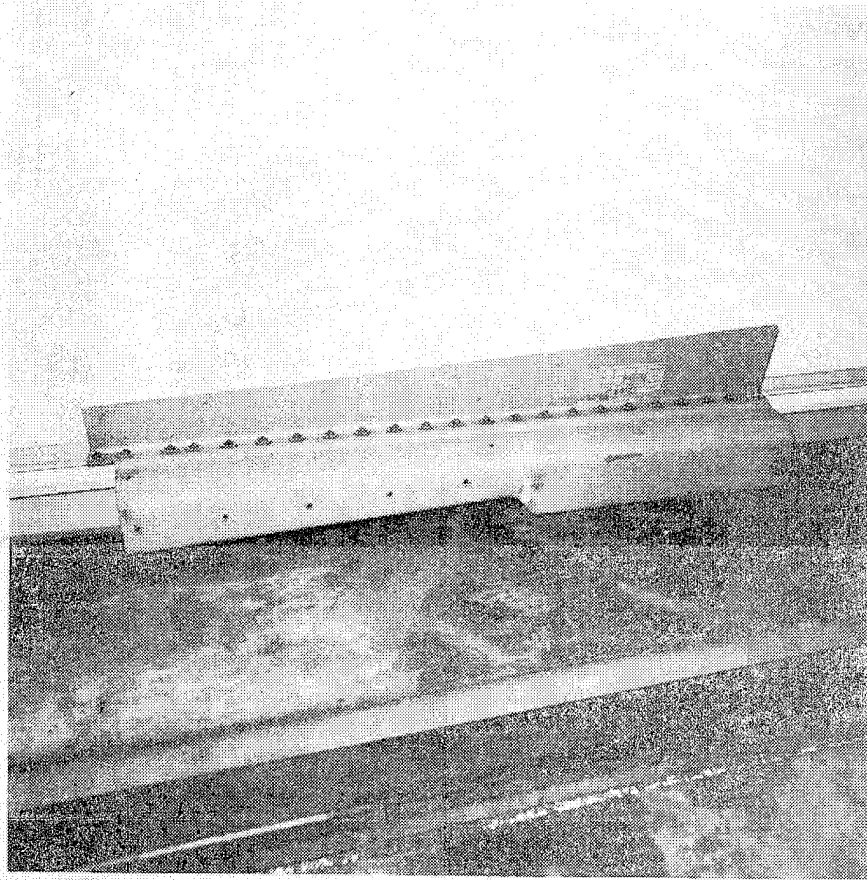
Figure 2. - Right-hand under-wing fillet-inner surface.

- o A left-hand and right-hand set of a small 23- by 84-cm (9- by 33-in.) solid laminate wing-body filler panel. The laminate incorporates nine plies of 181 style Kevlar-49 fabric and is approximately 0.25 cm (0.1 in.) thick (figure 2).
